MacBook Pro 13" Unibody Early 2011 Hard Drive Cable Replacement

Replace the hard drive cable in your Early 2011 MacBook Pro 13" Unibody.

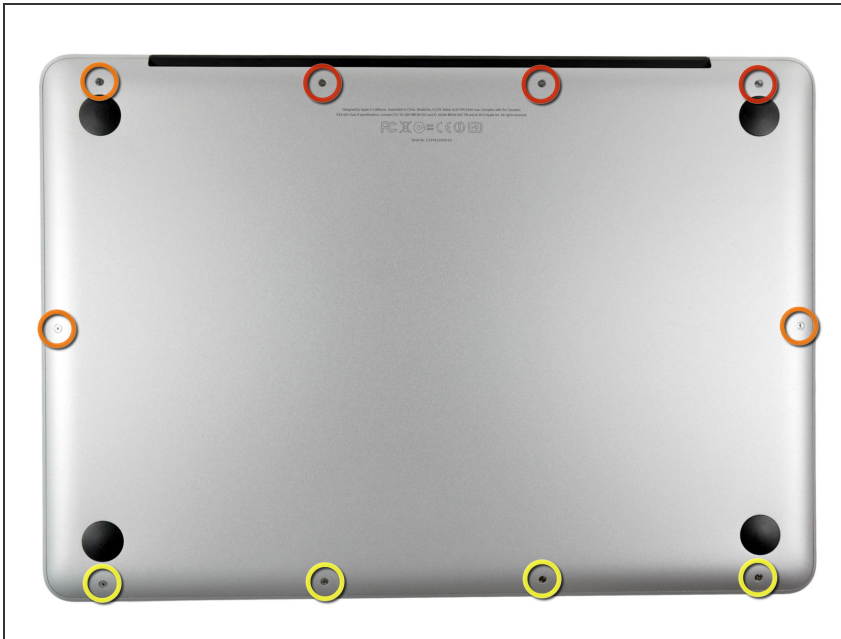
Step 1 — Lower Case

- Remove the following ten screws:
 - Three 14.4 mm Phillips #00 screws
 - Three 3.5 mm Phillips #00 screws
 - Four 3.5 mm shouldered Phillips #00 screws

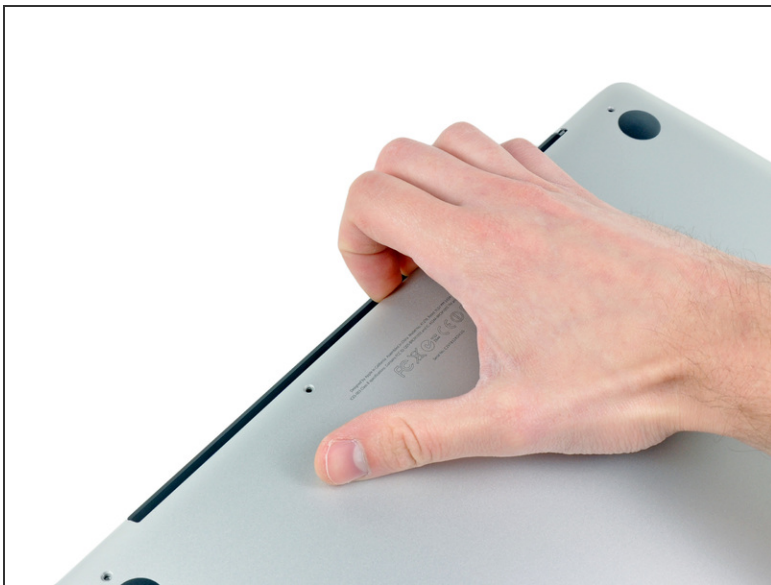
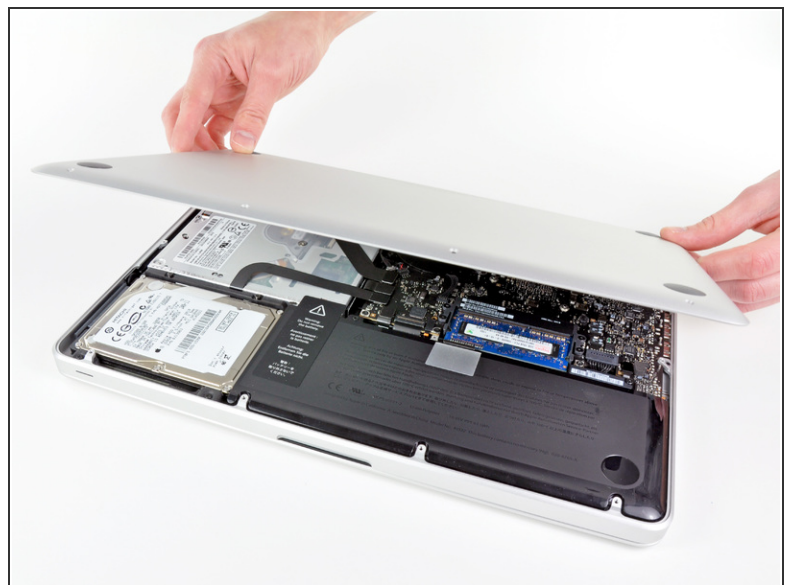
Step 2

- Use your fingers to pry the lower case away from the body of the MacBook near the vent.
- Remove the lower case.

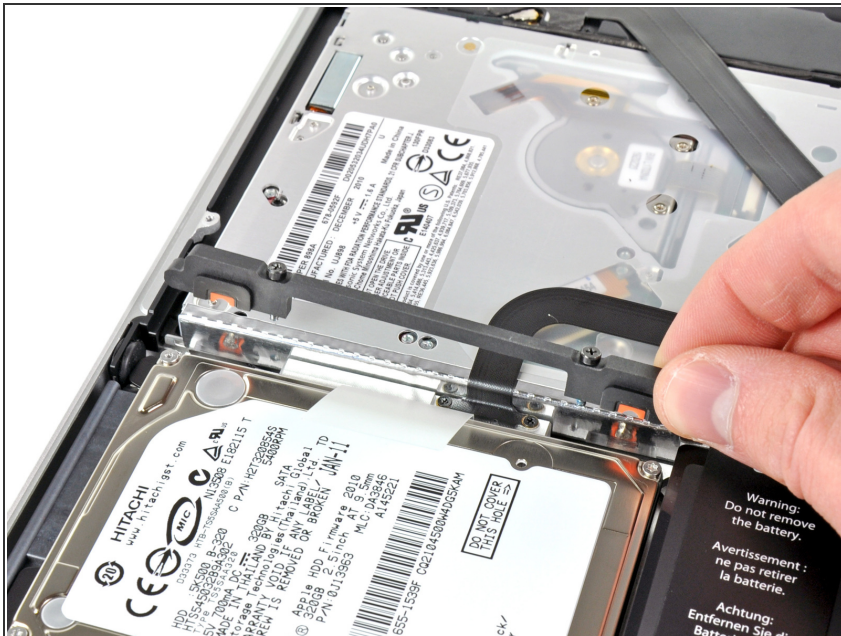
Step 6

- Remove the hard drive bracket.
- ⓘ The hard drive bracket may be firmly seated against the upper case.

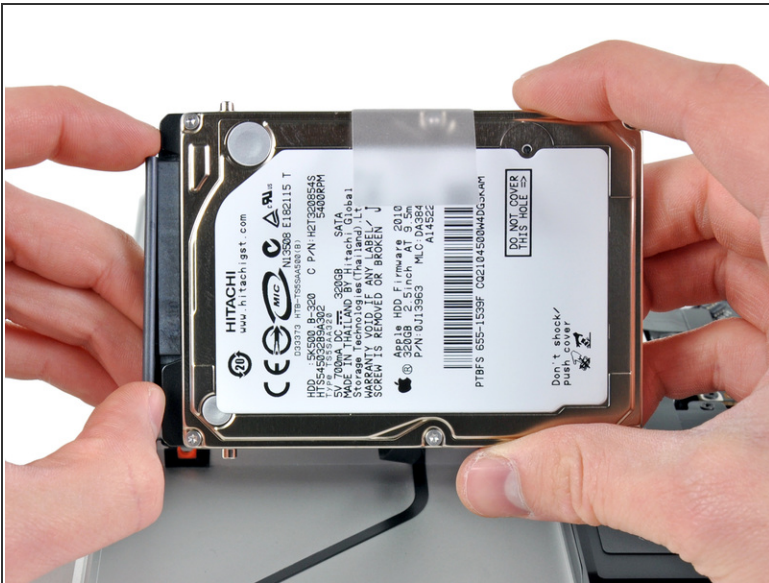
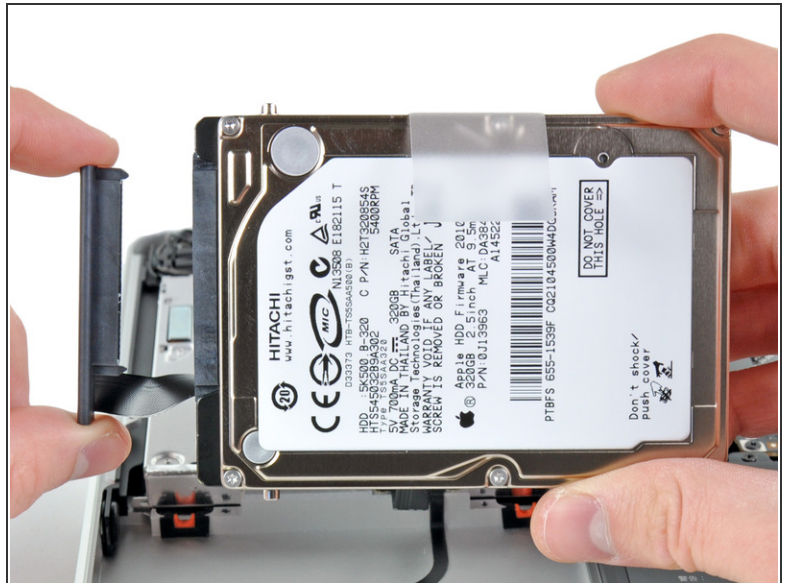
Step 8

- Pull the hard drive cable away from the body of the hard drive.
- Remove the hard drive.
